Damage Control: the Blakeley Trail Ravines Stabilization Project

November 2014 Snapshots

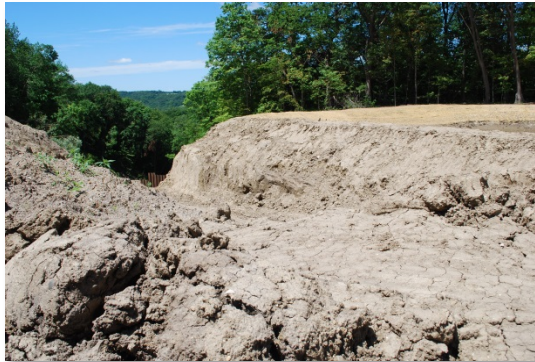
In the wake of the rain, a number of landslides occurred, closing County Road 60 and covering the construction area in debris. The sediment basin was damaged, the retaining wall washed away, and significant erosion occurred. The WMO worked quickly to salvage what they could, with their first priority being to stabilize the ravine and a roadway that was so unstable it moved as inspectors investigated damage to protect the Town of Blakely below.

Pictured, top: This July 2014 photo shows significant project damage. Middle: September, after the project had been rebuilt. Bottom: Check dams will help slow water and sediment flow, reducing erosion.

When it became clear there was no rebuilding County Road 60 to its former state, it was cut down. The sand and materials from the road were used as fill to stabilize north side of the ravine where the retaining wall had been, a move that not only salvaged the project, but brought it in under

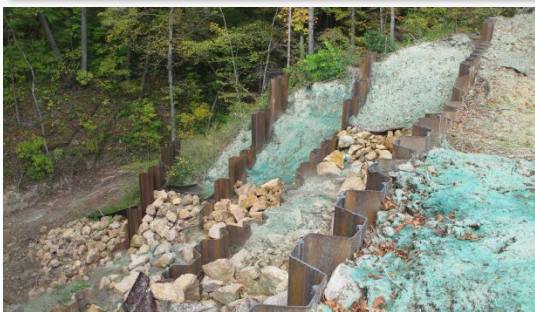
Original plans for the site included the construction of a water and sediment control basin and six check dams – used to slow water and sediment flow - to stabilize the ravines, protecting private property and the county road while reducing sediment from entering the Minnesota River. Funding included a \$381,000 Clean Water Fund grant from the Board of Water and Soil Resources, roughly a third of the project's total cost.
