Root River SWCD project targets trout habitat, aims to curb flood damage and sedimentation

The Root River SWCD project in the Crooked Creek watershed drew from a Watershed-Based Implementation Funding grant. The Clean Water Fund supports WBIF.

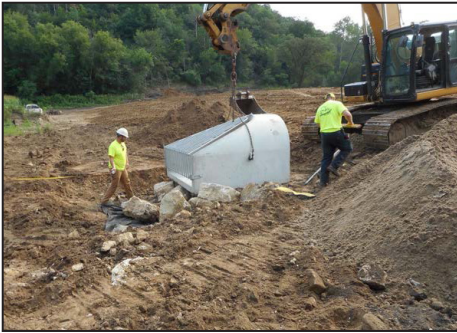
Left: Workers positioned an outlet pipe at the site of a flood- and erosion-control project in the Crooked Creek watershed near Caledonia in August 2021.

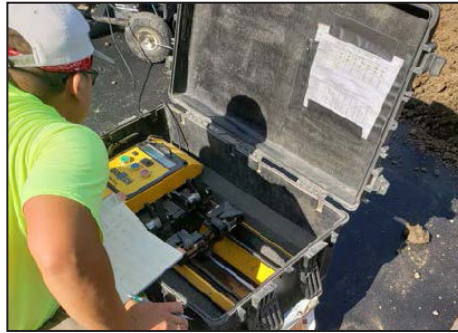
Middle: A worker tested the tensile strength of heat-sealed seams.

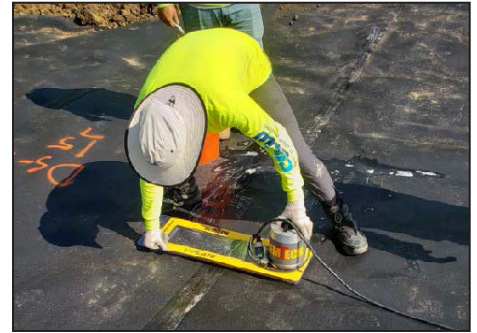
Right: A vacuum was used to check for leaks in the seams in September 2021.

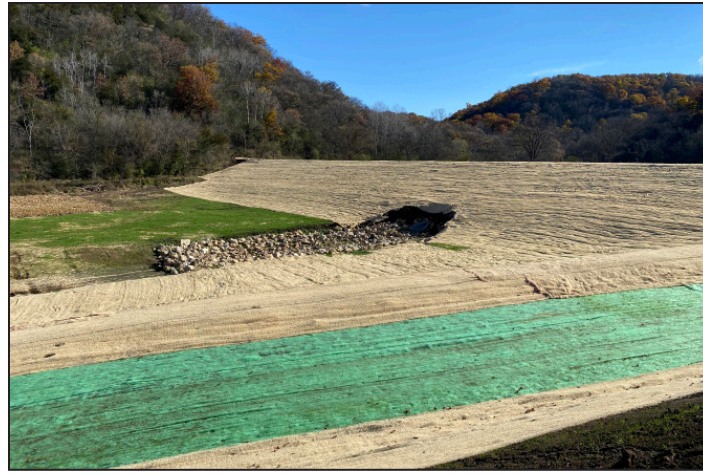
*An earthen dam is designed to reduce flood damage and sediment-loading to Crooked Creek, a Mississippi River tributary in Houston County. The site in Winnebago Township is seen here in November 2021, shortly after it was seeded. **Photo Credit:** Adam Beilke, BWSR*

The 28-foot-high earthen dam constructed in the 70-square-mile Crooked Creek watershed, which begins in Caledonia and flows east toward the Mississippi River, is designed to reduce flood damage, curb sediment-loading to Crooked Creek, protect roads and agricultural land, and improve wildlife habitat.

The pond created by the dam is designed to hold back a 50-year flood event — one that has a 2% chance of occurring in that location in any year. The structure is projected to reduce by 56% the outflow across a 1,010-acre area that includes cropland, pasture, forest and land enrolled in the federal Conservation Reserve Program. With about 110 acre-feet of storage, the structure helps to address the 10-year goals for the watershed in the [Root River Comprehensive Watershed Management Plan](#). The plan aims to curb sediment-loading by 5,393 tons a year, and provide 433 acre-feet of storage to handle two-year, 24-hour runoff events. The structure is expected to reduce sediment-loading by 1,226 tons per year.

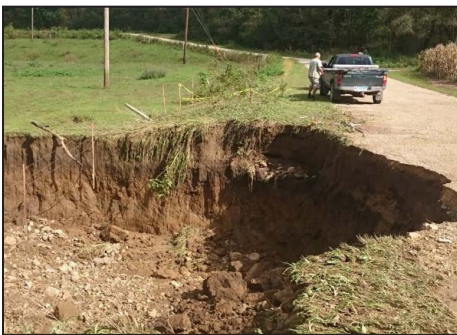
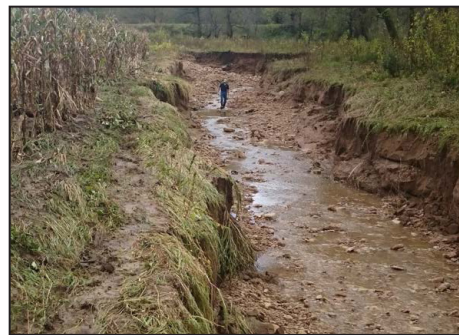
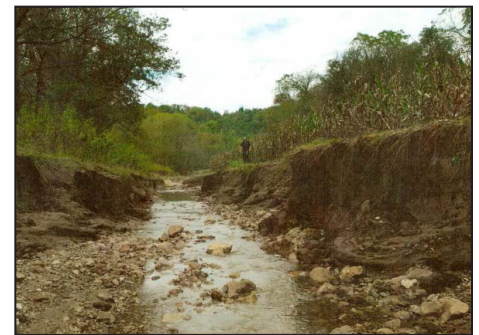
*Flood damage from a single-day event in 2016 washed out part of a township road, **left**, and, elsewhere in the watershed, **middle and right**, carved a gully a half-mile long and 2 feet to 12 feet deep. **Photo Credits:** Root River SWCD*

In 2016, another round of heavy flooding cut a half-mile-long gully in Winnebago Township that reached 12 feet deep at its deepest point.

The 2016 flooding damaged roads and culverts, wiped out agricultural crops, and deposited debris across farm fields, residential areas and public rights of way. Floodwaters carried thousands of tons of sediment into Crooked Creek, a designated trout stream with rainbow trout and brown trout. Settled sediment can clog pebbly streambeds where trout lay their eggs. Suspended sediment particles can block sunlight, killing important aquatic plants needed for a healthy habitat. Additionally, sediment absorbs warmth from the sun and increases the water temperature.
