WILKIN SOIL & WATER CONSERVATION DISTRICT

Decade of ditch projects

Otter Tail River basin work enters final phase

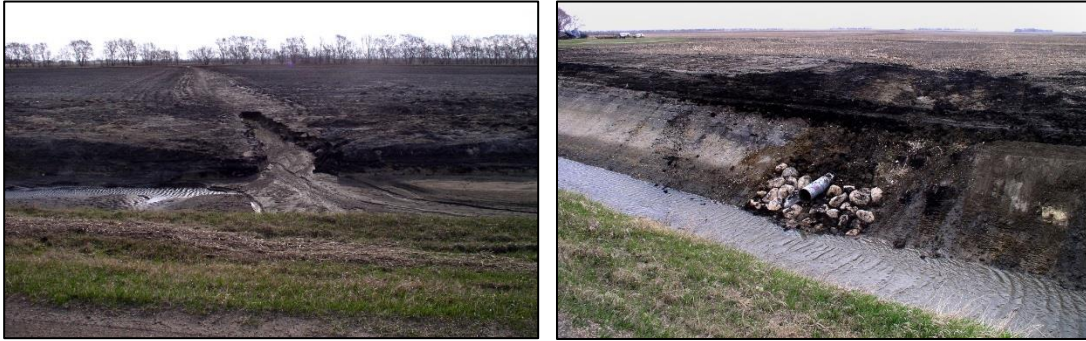
Left: Previously, uncontrolled runoff caused severe erosion that contributed to Otter Tail River pollution. Right: Now, side-inlet structures control field runoff, reduce erosion and improve water quality in the Otter Tail River.

Each structure is designed to fit the drainage area. Culverts in the berm connect ditch to field.

When the water level in the ditch rises, the water pressure pushes a flap-gate shut. That forces water behind the dike to stay on the field. Once the water level in the ditch drops, the flap-gate slowly releases water back into the ditch.
