Carlton SWCD improves safety, habitat

A rebuilt, free-flowing stretch of Skunk Creek that fixed an eroding county road and reconnected a stretch of trout stream is among Clean Water Fund-backed projects that remove experimental, 1970s structures. Partners included the DNR, U.S. Fish & Wildlife Service, and Carlton Transportation Department.

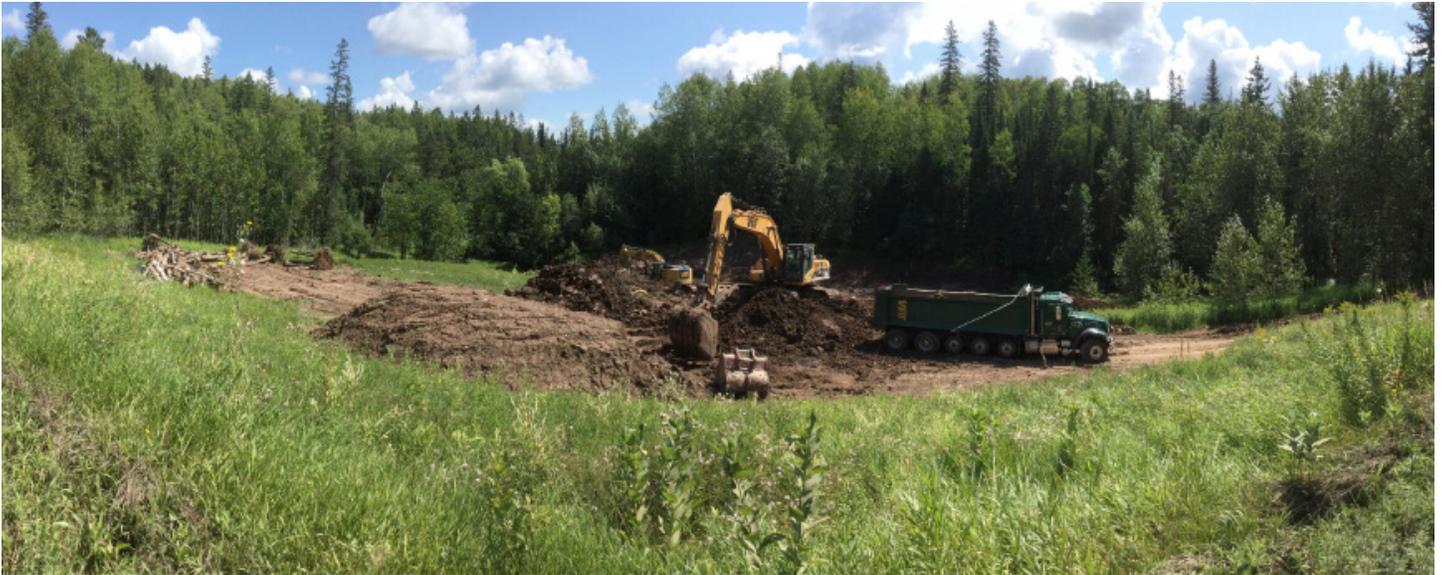
A Carlton SWCD project moved Skunk Creek away from a county road and, farther downstream, removed a structure built in the 1970s to stabilize the road by diverting the creek into a concrete culvert. The project, which finished in August, reconnected a stretch of trout stream to Lake Superior. A Clean Water Fund grant from the Minnesota Board of Water and Soil Resources is in play.

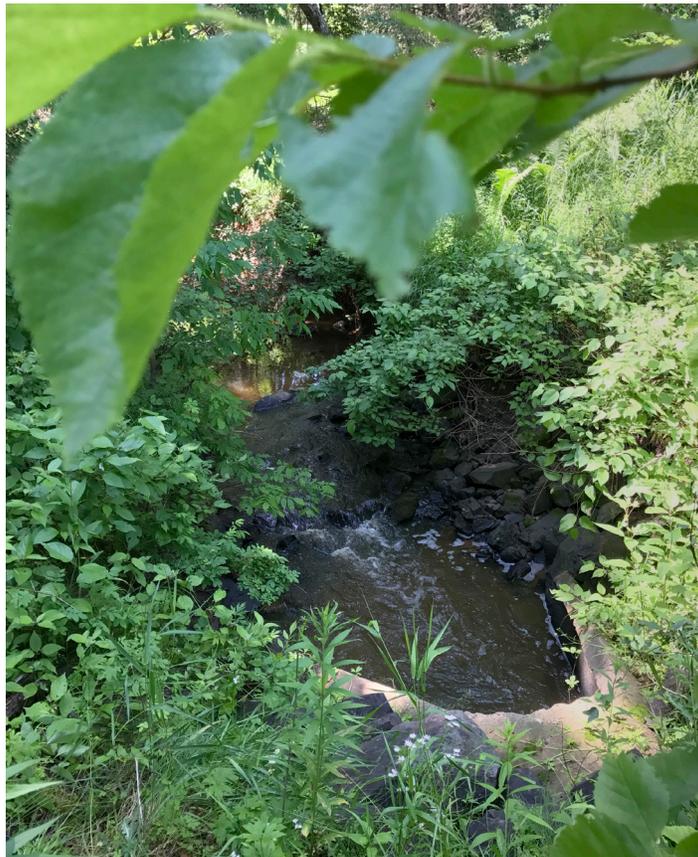
The 1970s structure forced the 20-foot-wide stream through a 4-foot pipe, seen here in 2017. Photo Credit: Ann Wessel, BWSR

The 1970s project forced a 20-foot stream through a 4-foot pipe.

“When you do that, you get the firehose effect. You get a huge increase in velocity,” Bomier said. “The fish aren’t able to move up that pipe because the water is too fast for too far.”
