Water quality is ditch fixes' No. 1 goal

Roseau River Watershed District’s Clean Water Fund project curbs rain-induced, perennial erosion; brings a 100-year-old system in line with modern ag practices

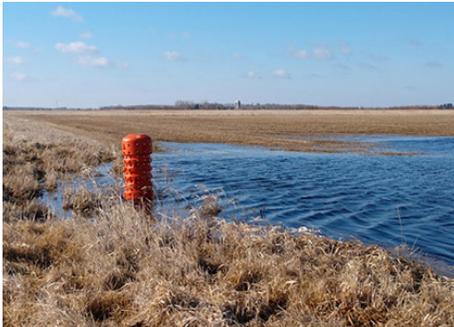
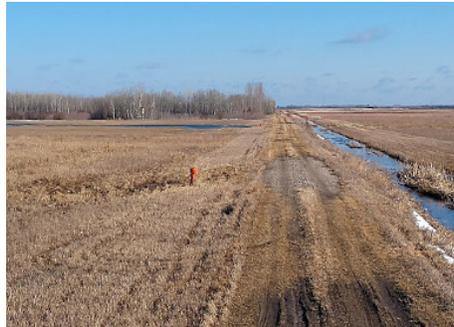
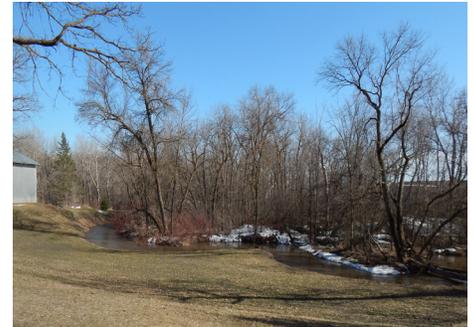
Left, Middle: Nine side-inlet control structures were installed in fall 2016 where a lateral feeding County Ditch 8 runs parallel to a mile-long stretch of minimum-maintenance road. Crushed asphalt tops the road where culverts were installed. The road slices through long, linear wetlands. This is the April 7, 2020, view, showing a perforated, above-ground inlet pipe that provides another release for backed-up water in spots where water is meant to stand for a short time, allowing sediment to settle out. **Right:** The re-sloped streambank stabilization, pictured here after a high-water event in 2019, has functioned as intended. **Photo Credit:** Torin McCormack, RRWD

At the first stop, where nine side-inlet control structures were installed, a lateral ditch and mile-long, minimum-maintenance gravel road cut a perpendicular line through those wetlands. The road had washed out in the middle and had been cut in low, swampy spots. Fields were drained directly into the ditch.

Crushed asphalt now tops the road where side inlets were installed. The structures allow sediment to settle back onto the land, reducing the load downstream. The ditch will become more efficient as sources of inland sedimentation are fixed, and the overgrown willows and cattails are cleared.

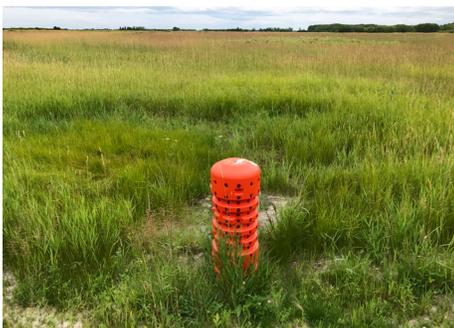
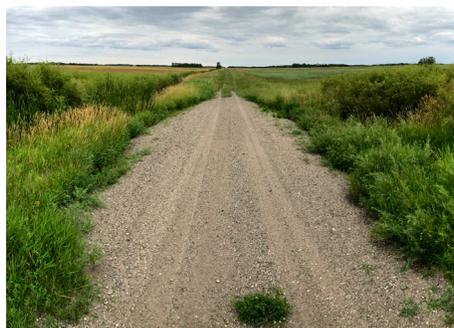
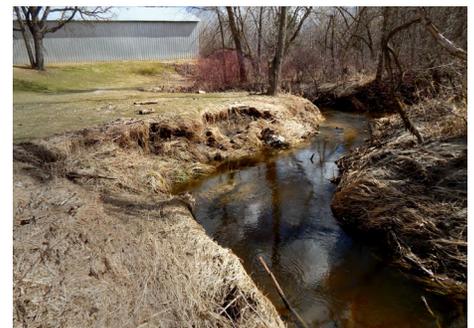
Left, Middle: This view depicts conditions of the lateral feeding County Ditch 8 and the minimum-maintenance road in 2017. Plans called for clearing cattails, other plants and trees from that lateral ditch once fixes were made farther up in the watershed. In the past, some landowners had cleared ditches or cut channels themselves. **Photo Credits:** Ann Wessel, BWSR **Right:** The stream that connects Roseau County Ditch 8 to the Roseau River threatened to undercut an 80-foot-long shed on private property. **Photo Credit:** RRWD

Michelle Mekash had noticed plenty of erosion on her land south of town, where a stream connecting County Ditch 8 to the Roseau River threatened to undercut an 80-foot-long shed.

“They’re straight vertical walls, and they continue to fail over time into the channel and then wash away downstream,” McCormack said.

The stabilization has withstood several high-water events. The yard no longer is eroding into the stream.

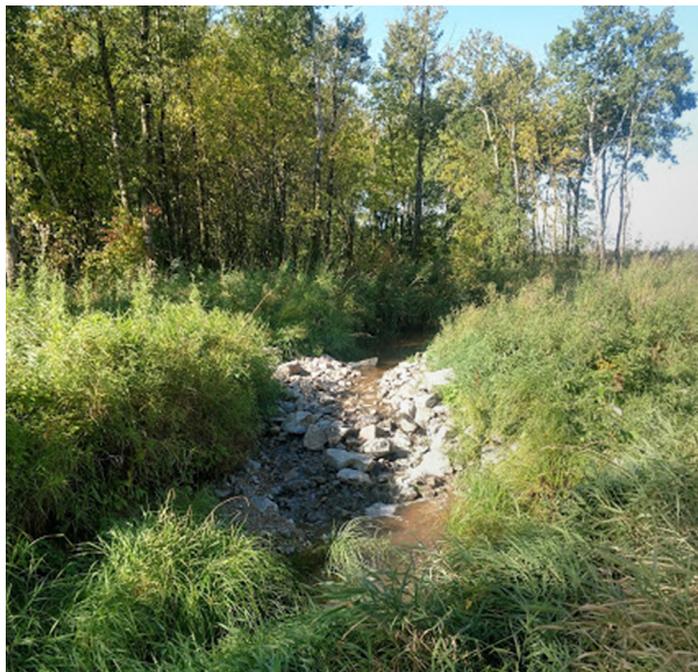
The vegetated drop structure, the only element of the County Ditch 8 project damaged since construction, is pictured here one month after repairs. Photo Credit: Torin McCormack, RRWD

Only one of the County Ditch 8 project sites has required repairs. It was damaged in a flood and fixed shortly thereafter.
