# Cooperation, collaboration drive Pope, Swift county conservation

BWSR Clean Water Funds, NRCS assistance support East Branch Chippewa River watershed work

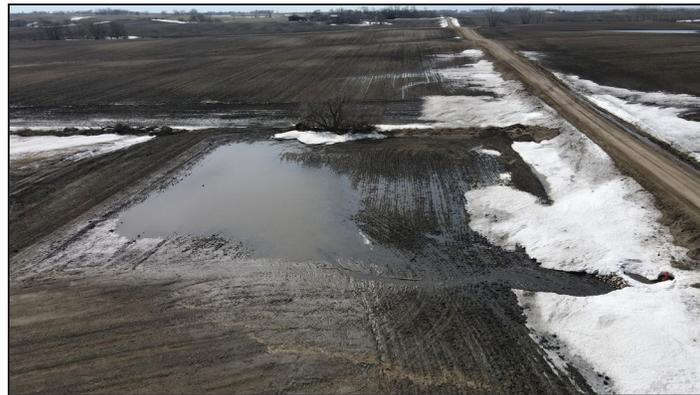
After a sudden warmup followed heavy snows, a water and sediment control basin worked as designed in spring 2023 in a field Mark Thompson farms in the East Branch Chippewa River watershed. Before the basin was installed, a sudden spring melt would have carved gullies into the field. **Photo Credit:** Andy Albertsen, Swift County SWCD

Both worked with the Swift County SWCD. The resulting projects — four water and sediment control basins constructed in spring 2023 on either side of the township road that divided them — drew from the Clean Water Fund grant, and Pope and Swift County SWCDs’ local cost-share funds. Thompson initially raised the resource concern; preliminary plans revealed the project’s success hinged on capturing and slowing water from the north. Tying the two projects together made it possible to treat water from a larger area. The basins and related tile will also alleviate flooding on the township road, where a culvert was replaced this spring.
