Upstream battle

Stream restorations, removal of failed '70s dams feed hopes of brook trout, stanch flow of red-clay sediment into Lake Superior

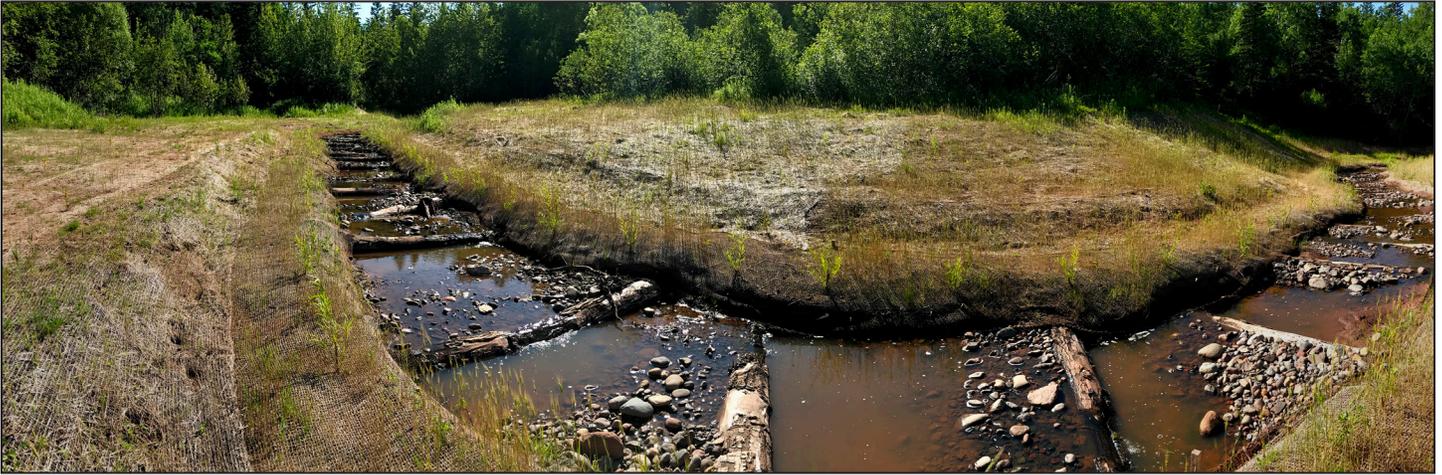
Each boulder and log is placed to curb velocity and direct the flow of a 500-foot-long, remeandered stretch of an unnamed Deer Creek tributary. A floodplain remains visible on July 14, 2017, as native grass grows through straw and coconut fiber mats. After a red clay dam built here in the 1970s failed, the tributary cut through an embankment. The Minnesota Board of Water and Soil Resources awarded Carlton SWCD \$271,800 over three years to deal with the dams.

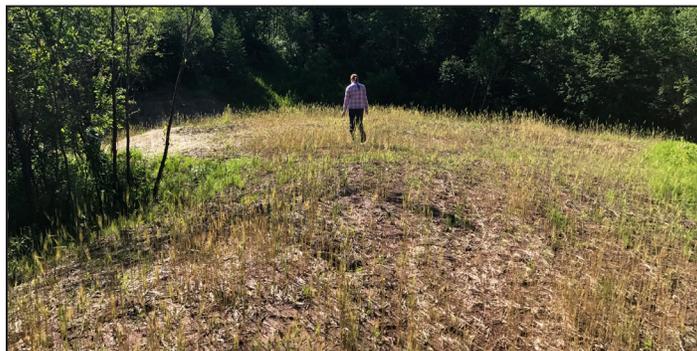
Melanie Bomier, Carlton Soil & Water Conservation District water resources technician, puts into perspective the size of a project that replaced a failed red clay dam.

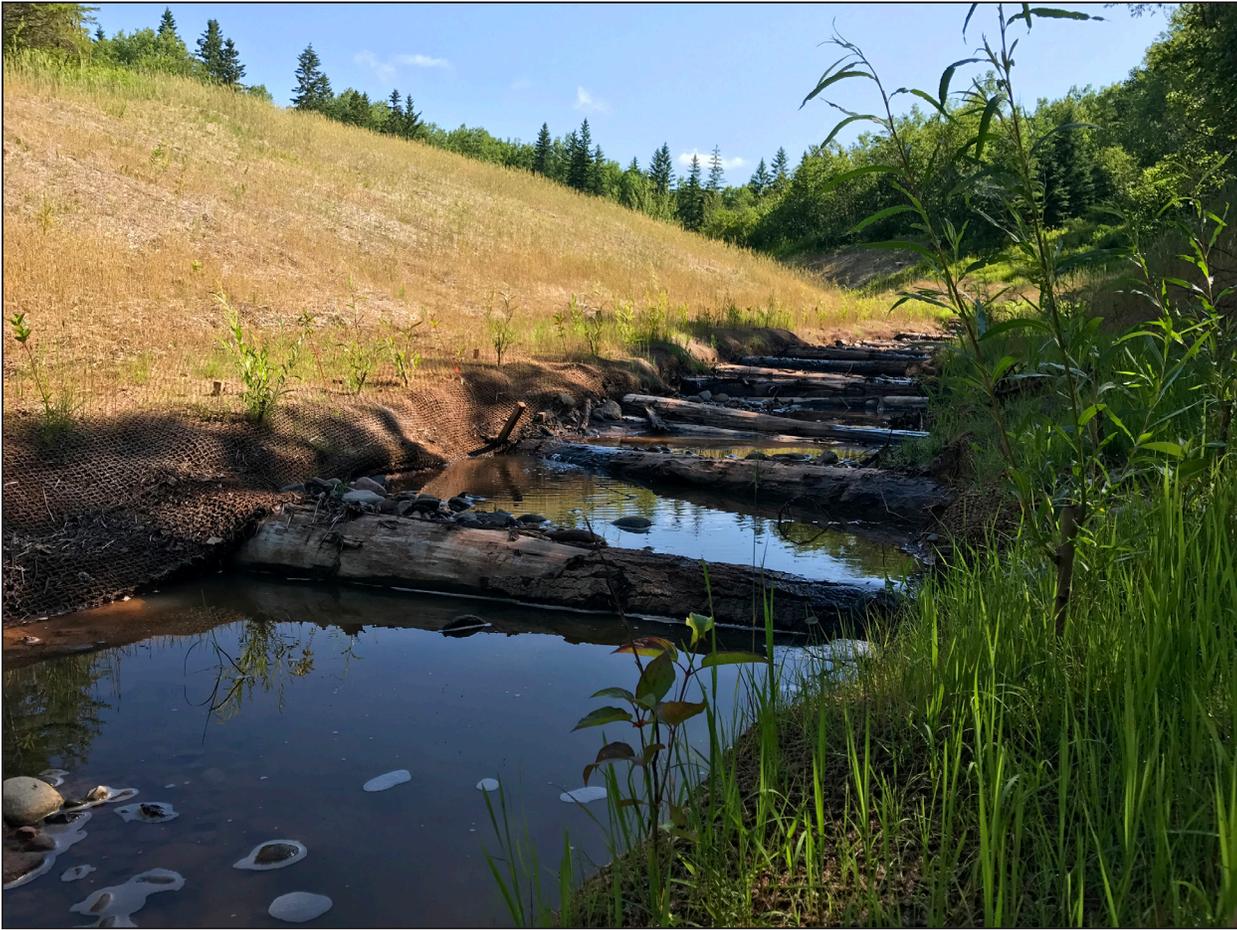
Aspen logs stacked two high and anchored by rocks form steps in a 500-foot-long segment of remeandered stream. Technical Services Area No. 3 staff engineered the project.

NEW TECHNIQUE: Aspen logs stacked two high and anchored on both ends by rocks form the “steps” of the remeandered tributary that empties into Deer Creek. It’s the first project of its kind for the Technical Services Area 3 staff, which provides engineering services to the SWCD.

The contractor chose aspen because it was readily available from a local logger.

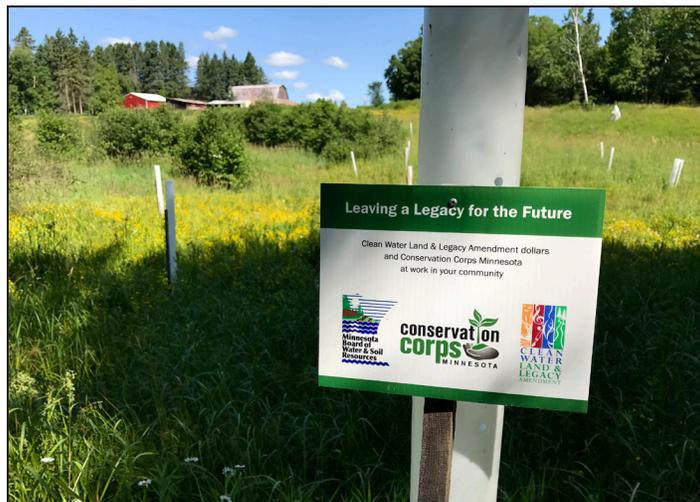
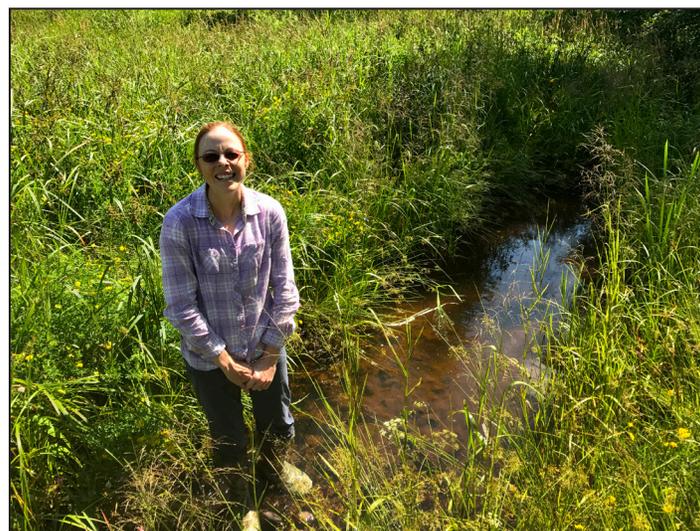
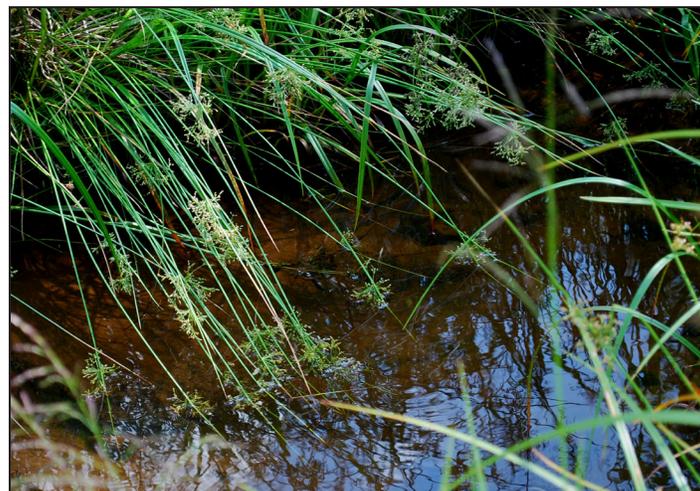
Top: A tree planting was part of the restoration of Elim Creek, where three failing red clay dams were removed and a one-third-mile-long segment of stream was restored in 2014. The streambanks are no longer grazed. **Middle:** Bomier visits Elim Creek in July 2017. The grasses and forbs have grown up to the point that locating the stream is difficult. **Bottom:** Grasses bend over a reameandered stretch of the creek.

One of the three dams had failed, releasing 300 tons of sediment. The two remaining threatened to release 965 tons more. The dam removals and brook trout habitat restoration were completed in 2014.

Today, the stream is fenced off. Trees clad in protective tubes grow on a hill above 2,000 feet of reameandered stream. Elim Creek empties into Skunk Creek, which joins the Nemadji River.

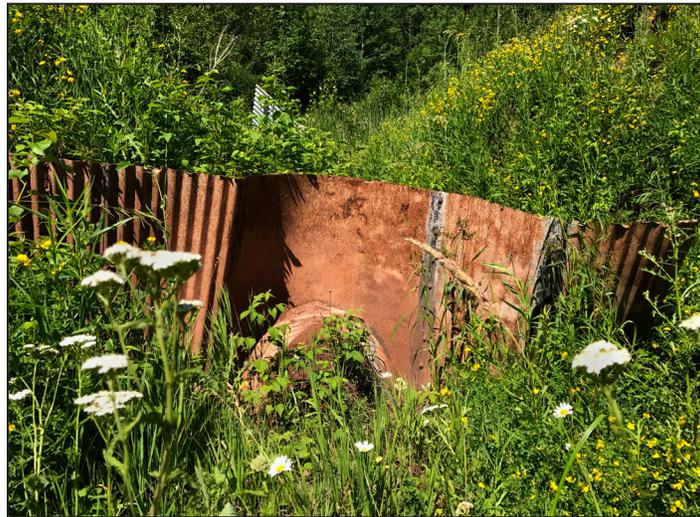
Top: Before the dam blew out 10 or 15 years ago, an Elim Creek tributary flowed through a culvert here, eventually feeding the Nemadji River and Lake Superior. The Nemadji deposited 98,000 tons of sediment a year into Lake Superior. Landowner Wendell Lund helped clear the land when the dam was constructed in the 1970s. **Above:** Because landowners weren’t involved when the dams were built, they don’t contribute financially. Carlton SWCD must have landowners’ permission to pursue projects on their property.

designs for a third failed red clay dam site. There, slumping banks of an Elim Creek tributary widened the gap, revealing rusted culverts through which water once flowed. Upstream, cattails choked a once-open pond.

Lund figured the dam blew out all at once, 10 or 15 years ago. He hadn’t seen signs of erosion, hadn’t seen water cut a new channel around the spillway.
