Carlton SWCD improves road safety, trout habitat on Nemadji River tributary

A rebuilt, free-flowing stretch of Skunk Creek that fixed an eroding county road and reconnected a stretch of trout stream is among Clean Water Fund-backed projects that remove experimental, 1970s structures. Partners included the DNR, U.S. Fish & Wildlife Service, and Carlton Transportation Department.

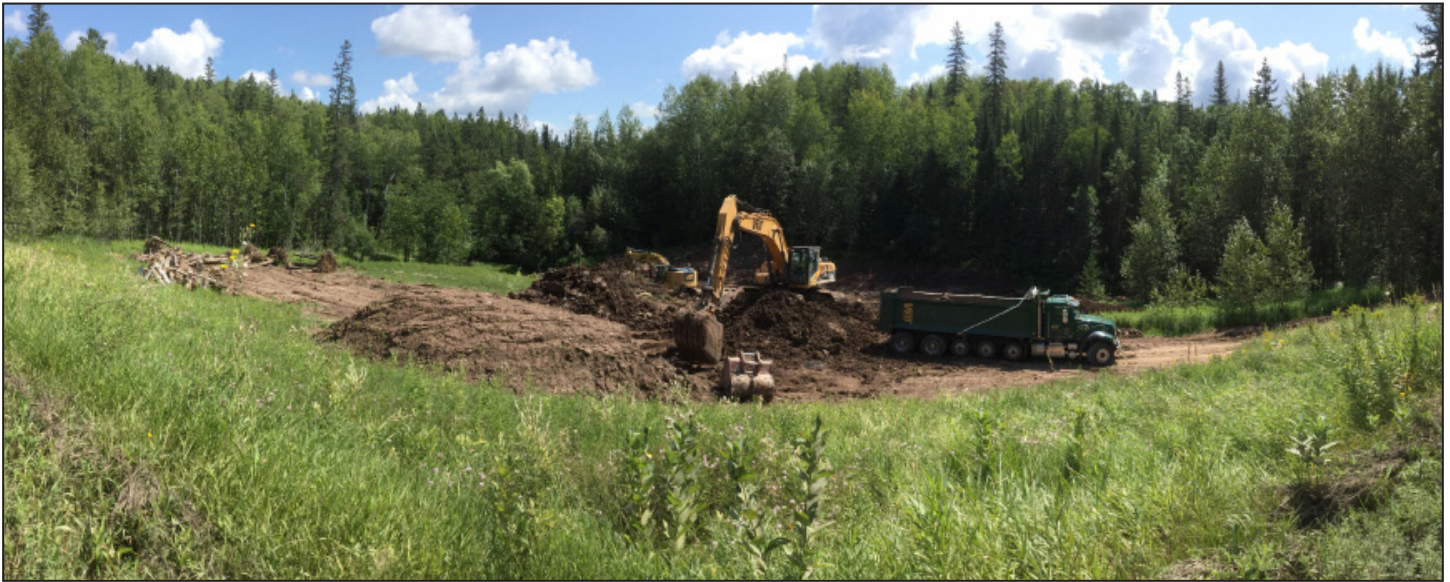
Photo Credit:
Carlton SWCD

A Carlton SWCD project moved Skunk Creek away from a county road and, farther downstream, removed a structure built in the 1970s to stabilize the road by diverting the creek into a concrete culvert. The project, which finished in August 2019, reconnected a stretch of trout stream to Lake Superior. A Clean Water Fund grant from the Minnesota Board of Water and Soil Resources is in play.

Contractors moved two 70-foot-long segments of the curving stream farther away from the highway. To attain optimal flow, the rerouted stream incorporated width and length calculations plus floodplain connections.

Toe-wood structures armored the banks and diverted the fast, erosive flow. Strategically placed root balls (trees with roots attached) plus boulders diffused and directed the water. Rock J-hooks (lines of rocks angled upstream and then curved in mid-channel) helped to keep water from scouring the banks and created velocity-slowing pools. The reconstructed stream segments are a series of pools and riffles.

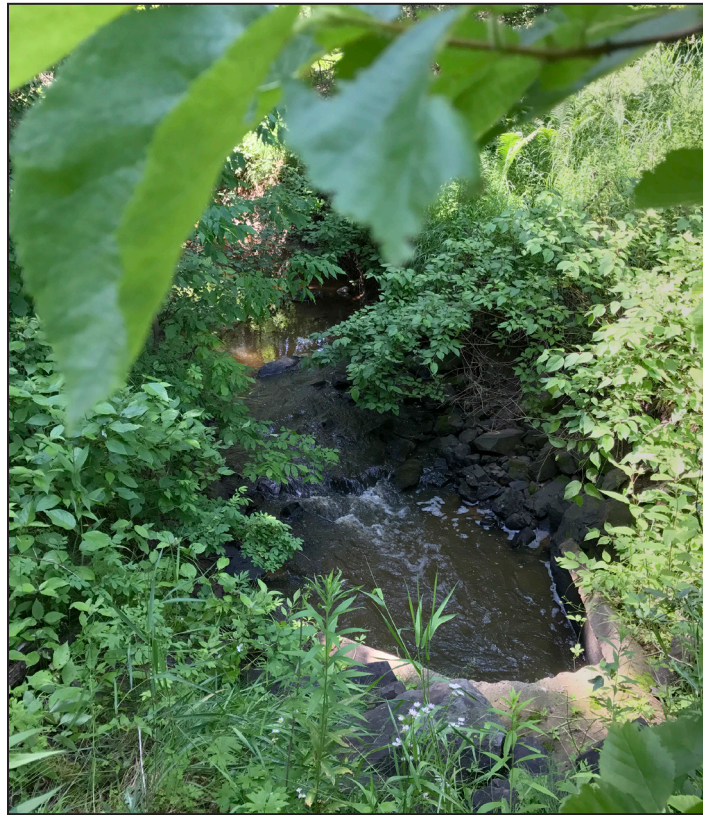
The 1970s project forced a 20-foot stream through a 4-foot pipe.

“When you do that, you get the firehose effect. You get a huge increase in velocity,” Bomier said. “The fish aren’t able to move up that pipe because the water is too fast for too far.”

The 1970s structure forced the 20-foot-wide stream through a 4-foot pipe, seen here in 2017. Photo Credit: Ann Wessel, BWSR

At a second site downstream, contractors removed a 1970s structure — an experimental design meant to reduce sediment and stabilize the road by diverting the creek into a concrete culvert. Over time, erosion had blocked fish passage and chewed away at the

road's edge. In recent years, water topped the concrete weir at least once a year — something engineers had estimated might happen once every four years.
