## ST. LOUIS COUNTY

# Culvert inventory paves the way for improved public safety, fish habitat

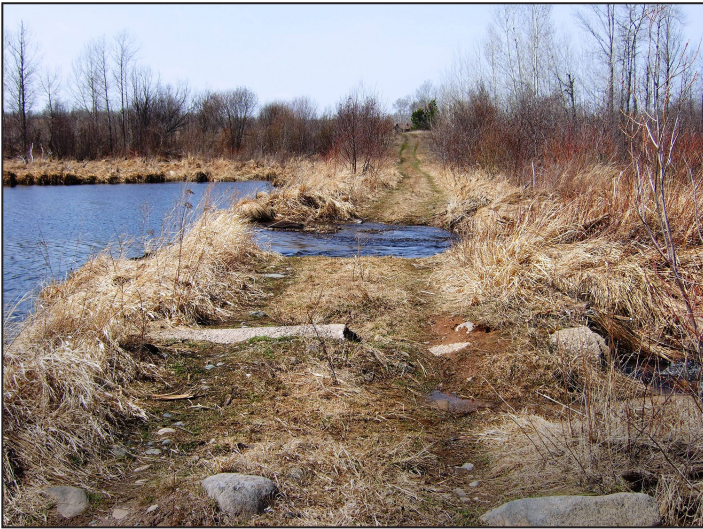
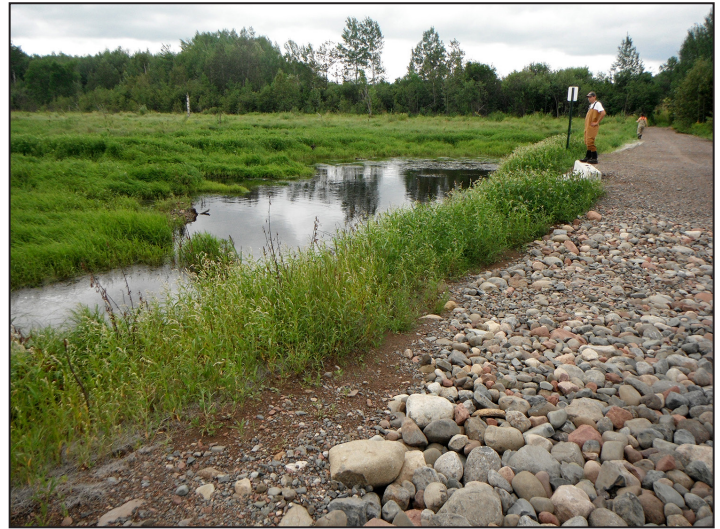
Before-and-after views of a failed culvert and collapsed road spanning Martin Branch, a trout stream that empties into Stoney Brook, illustrate the problem and solution. The culvert was removed and fixed in 2011, and held up well in the 2012 flood. The Fond du Lac Band of Lake Superior Chippewa has since seen the flooded wetland recover and the stream-dwelling macroinvertebrate population improve. **Photo Credits:** Fond du Lac Office of Water Protection

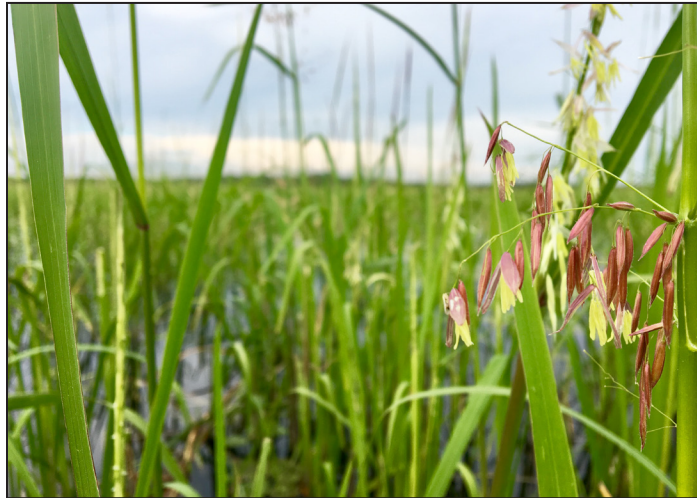
*Culverts play a role in regulating water levels for wild rice production.*

The 101,000-acre Fond du Lac Reservation spans St. Louis and Carlton counties. Because the topography is flat, Hedin said a small change in culvert size can have a big effect on road crossings and wild rice habitat. The grain is susceptible to fluctuations in water level.
