# Shingle Creek’s linked restorations augment habitat, curb bank erosion

Within the confines of an urban stormwater system that drains to the Mississippi River, Shingle Creek WMC’s Clean Water Fund-backed habitat and water quality work focuses on stretches within Brooklyn Park, Brooklyn Center

Clean Water Fund grants BWSR awarded Shingle Creek WMC in 2014 and 2021 support two segments of connected stream restorations.

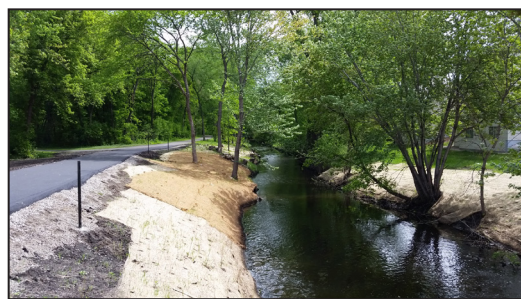
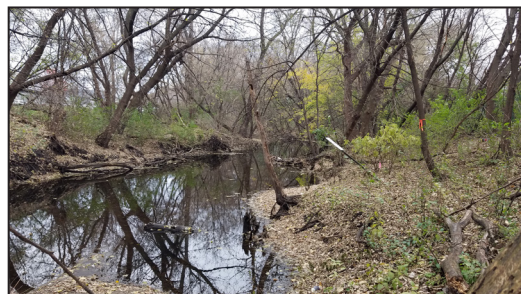
**From top:** By late summer 2016, native plants grew along Shingle Creek WMC’s Connections I stream restoration. Erosion control fabric covered native vegetation planted in spring 2016. A dense tree canopy appears along a segment of the planned Connections II project. **Photo Credits:** Shingle Creek WMC

Contractors planted deep-rooted native species to stabilize the banks, and thinned the trees to allow those plants to grow. Rocks placed within the creek improved aeration and habitat. A fish ladder replaced a 3-foot drop structure. A bit of re-meandering slowed velocity and further improved habitat.

A \$328,000 Clean Water Fund grant BWSR awarded in 2021 supports the second, 1,750-foot-long ecological restoration set to begin this spring. That project, which starts at Brooklyn Boulevard and extends upstream to the north and west, will thin trees, establish native plant streambank buffers, repair erosion and enhance habitat. Because it runs through private property, there is less opportunity for re-meandering.

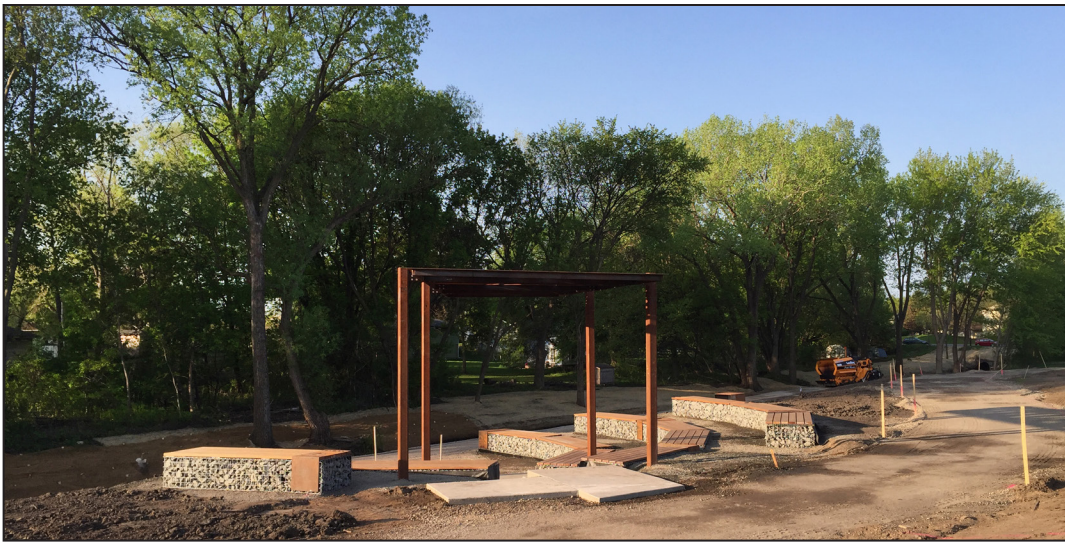
In Brooklyn Park, a trail connection and amphitheater-style overlook were constructed in conjunction with the Shingle Creek WMC stream restoration. **Photo Credit:** Brooklyn Park

The Connections sites’ linked walking trails and a new viewing area make it easier for people to see the progress, learn about the WMC’s work and get close
