# Pope-Swift SWCD collaboration optimizes erosion control work

A \$345,000 Clean Water Fund grant the Minnesota Board of Water and Soil Resources (BWSR) awarded to the Pope Soil & Water Conservation District (SWCD) in 2021 targeted erosion and sediment control within the watershed. An agreement between Pope SWCD and Swift County SWCD expanded the projects' scope to Swift County.

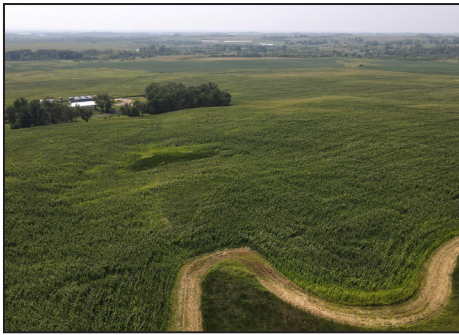
**Left:** An August 2023 drone image shows part of the Pope County project that involved eight water and sediment control basins, starting upstream on the Jergenson farm (the home site is pictured) and extending to the Rick Davidson farm.

The eight water and sediment control basins installed in fall 2022 — four on each farm — withstood their first test this spring.

Civil engineering technician Steve Linow of the West Central Technical Service Area said the basins were designed to handle a 10-year, 24-hour rainfall event — about 4 inches of rain in 24 hours — and then draw down within 48 hours. TSAs provide technical assistance to SWCDs.

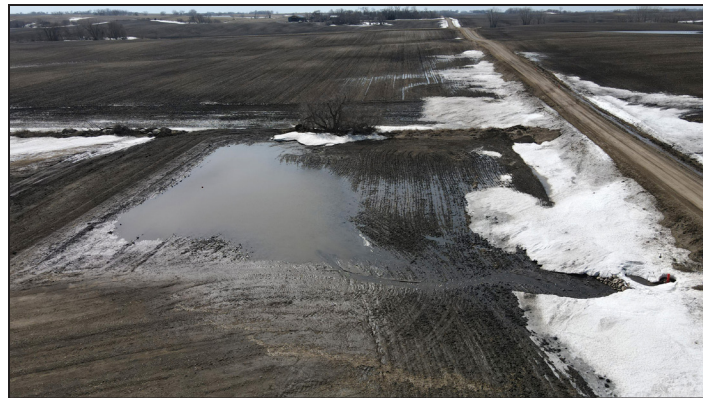
After a sudden warmup followed heavy snows, a water and sediment control basin worked as designed in spring 2023 in a field Mark Thompson farms in the East Branch Chippewa River watershed. **Photo Credit:** Andy Albertsen, Swift County SWCD

“We had a lot of snow this last winter, and when it warmed up all of a sudden to 75, 80 degrees this spring, the snow all melted in just two or three days,” Davidson said. “Every afternoon all the sediment control basins would be completely full of water, and by morning they’d be all empty again.”
