CLEAN WATER FUND TAX DOLLARS

Otter Tail River bank stabilization preserves farmland, pleases paddlers

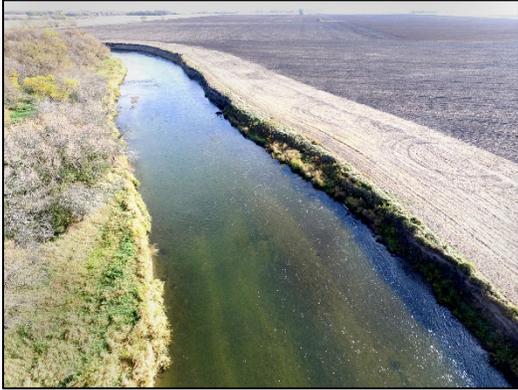
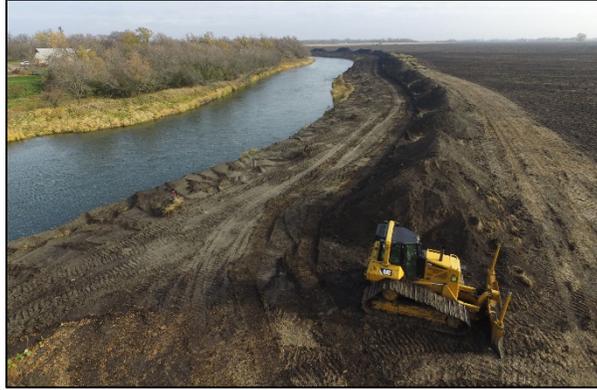
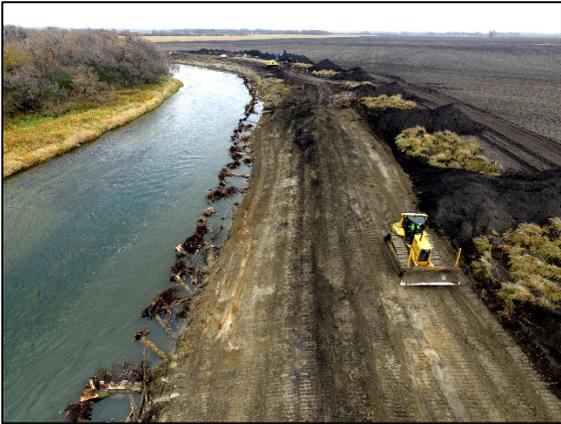
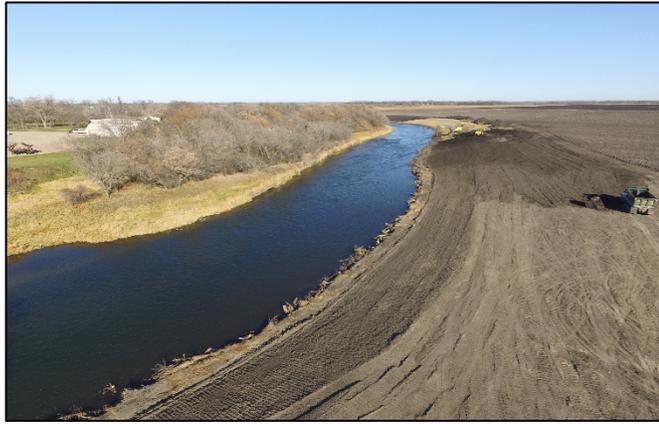
Top to bottom, left to right: Day 1 of a streambank restoration project on the Otter Tail River in Wilkin County shows, at right, the field that was eroding into the river. A \$135,000 Clean Water Fund grant restored a 1,200-foot stretch of the bank. Heavy equipment was at work on Day 9. The aerial view on Day 13 showed woody toe benches, with exposed tree roots facing the stream channel. "We did this particular application because it was going to be a lot less expensive than the traditional rock riprap," said Don Bajumpaa, Wilkin SWCD district manager. Grasses have grown up on the buffer since the final day of construction. **Photo Credits:** Wilkin SWCD

A \$135,000 Clean Water Fund grant the Minnesota Board of Water and Soil Resources awarded in 2016 aims to restore and protect 1,200 feet of streambank along that bend in the Otter Tail River. BWSR calculates improvements – including a graduated, grassed slope on land and strategically placed tree trunks and roots in the water – will keep 440 tons of sediment out of the river annually.

The SWCD partnered with the Buffalo-Red River Watershed District and the project engineer to create a floodplain and curb the water’s energy by installing woody toe debris benches in the eroded bank. Tree trunks’ exposed roots faced the stream channel.

Sod mats containing willows and other woody vegetation were placed on top of the benches, where they will stabilize soil. Grasses planted on the reshaped, more gradual slope will meet the willows and tie the project together. A widened buffer strip on top of the bank will control erosion.
