Twisted creek, restored habitat

In Rochester, \$1.5 million stream reconstruction on former golf course site provides water quality improvement, flood control

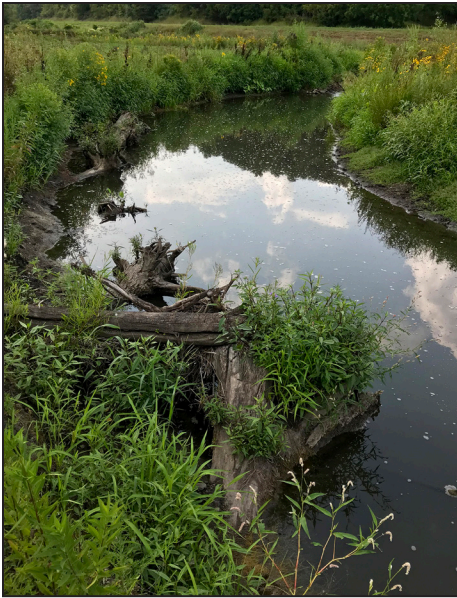
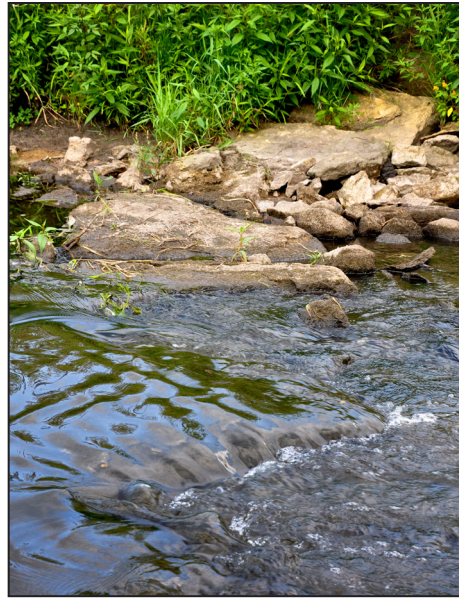
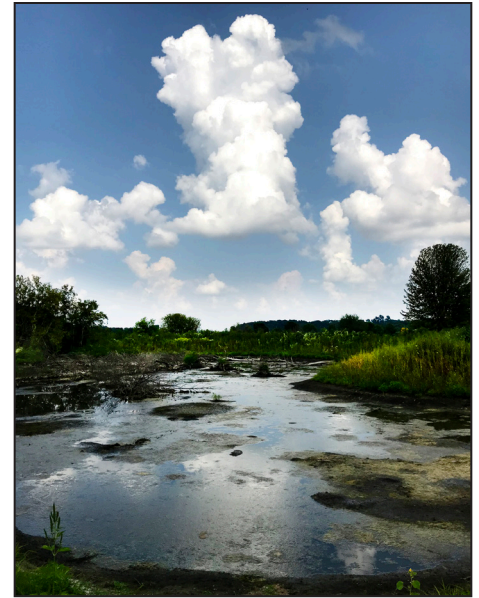
Left: Root wads help to stabilize the banks of the South Branch of Cascade Creek. **Middle:** Rocks were placed to slow the water, create habitat and stabilize the streambed of the South Branch of Cascade Creek. Curves were designed to help curb the velocity. **Right:** Wetlands eventually will fill with water. Logs and roots will help to create habitat. Engineers hope the wetlands will distract beavers and keep them from damming the creek.

Minnesota Department of Natural Resources staff designed the velocity-slowing curves, bank-stabilizing root wads and habitat-creating rock riffles. They selected native grasses, sedges and wildflowers to plant on the streambanks and upland prairie.

Only the five wetland basins, built this spring in the final construction phase, still looked manmade. They will treat stormwater, trap sediment, provide flood attenuation and eventually provide wildlife habitat. Engineers hope the wetlands will distract beavers and keep them from damming the creek.

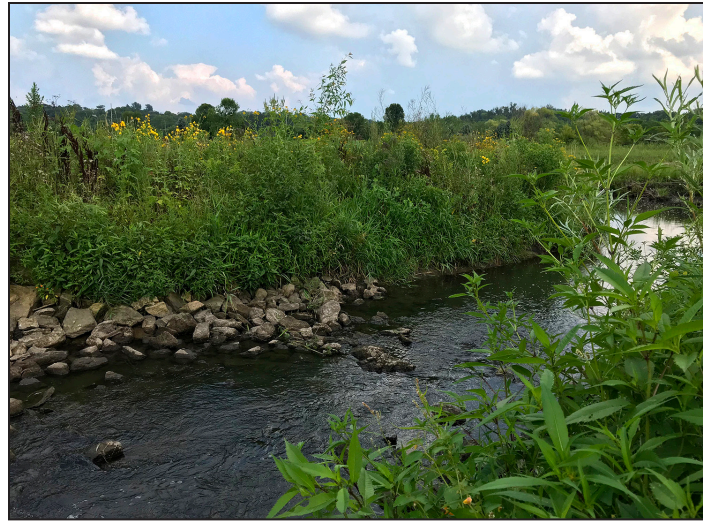
The redesigned South Branch of Cascade Creek mimicked the sinuosity, dimension and shape of a stable channel elsewhere in the watershed.

“We constructed a new channel based on the sinuosity, dimension and

shape of a channel higher in the watershed that had decent stability. We took a survey on that stable area, and then we mimicked it,” Langer said.

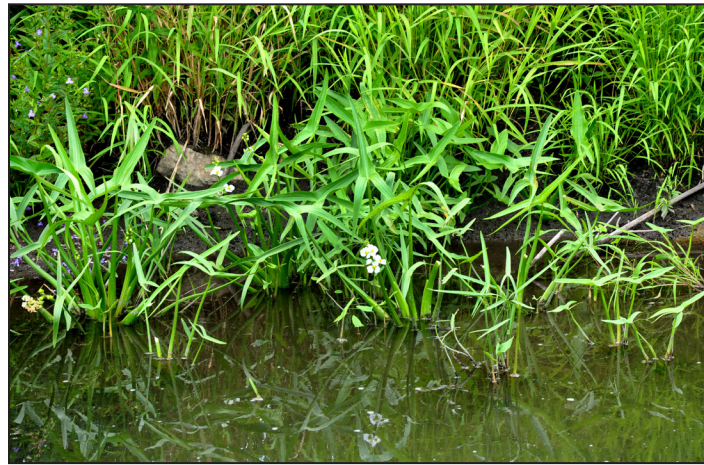
Aquatic plants bloomed in mid-August in the South Branch of Cascade Creek in Rochester. The restoration also included upland prairie plantings.
